REPORT

Testing of Rooftopcoat on bitumen roof material
for resistance to water and resistance to temperature changes

Client : RAW Paints BV
Leidsevaartweg 1
2106 NA Heemstede
The Netherlands
Contact person: Mr. P Ninaber

Report number : LAB19-0411-REP

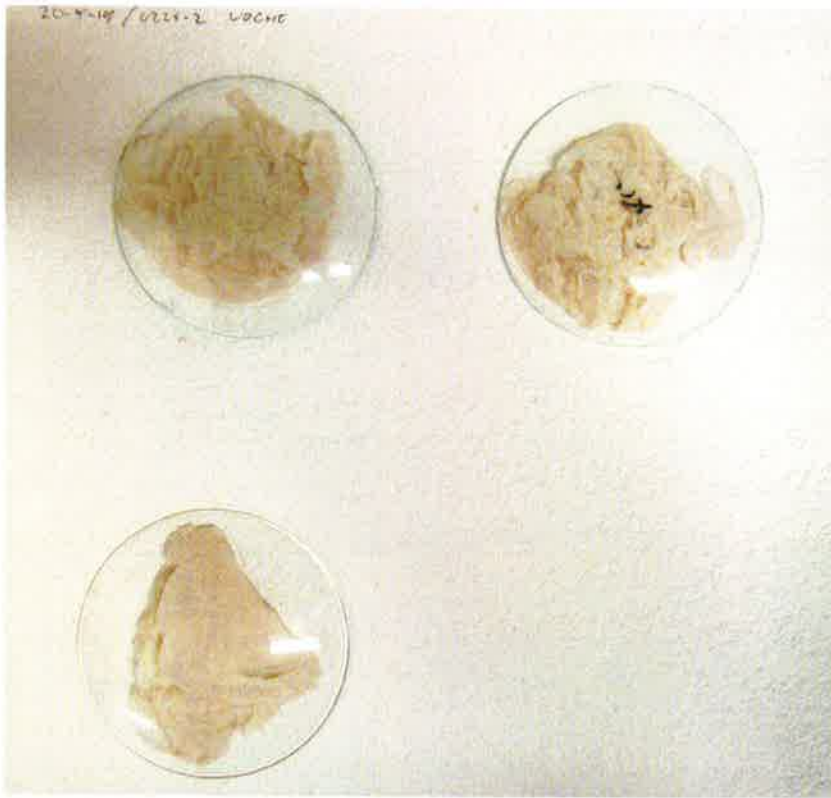
Photo 1: Watch glasses according to ISO 2812-1

Absorbance material has been soaked with demineralized water, placed on the coating material and covered with a watch glass. During the whole test period the absorbance material has been kept wet.

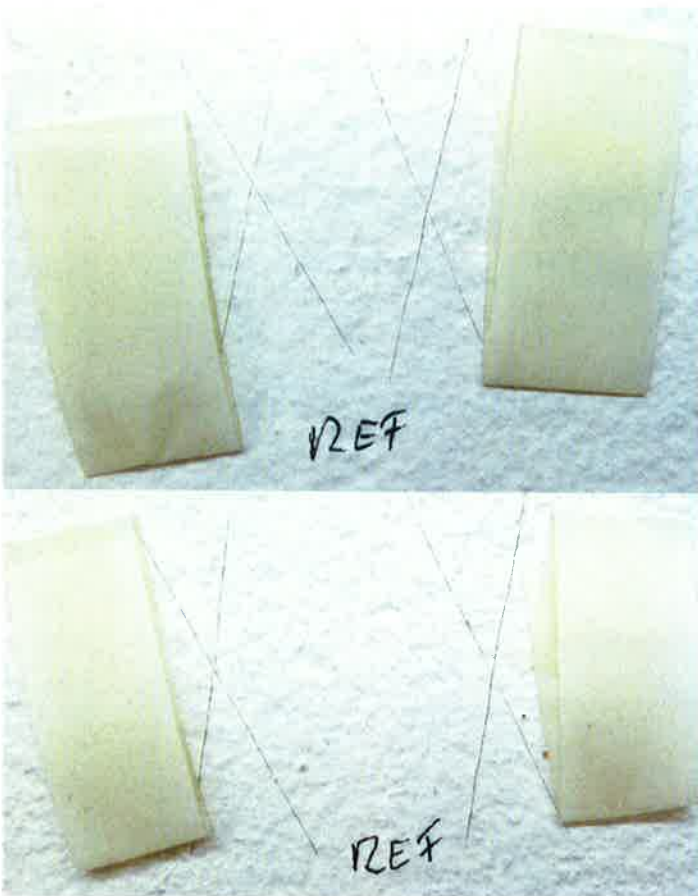
Photo 2: Reference adhesion

COT sample number	20-05-19/0225-1	20-05-19/0225-2	20-05-19/0225-3
Recovery period (hours)			
	Rating (class)		
Reference	Not exposed	5A, 5A	5A, 5A
0		3A, 3A, 3A	5A, 4A, 4A
1		3A, 4A, 4A	4A, 4A, 4A
24		5A, 4A, 4A	5A, 4A, 5A

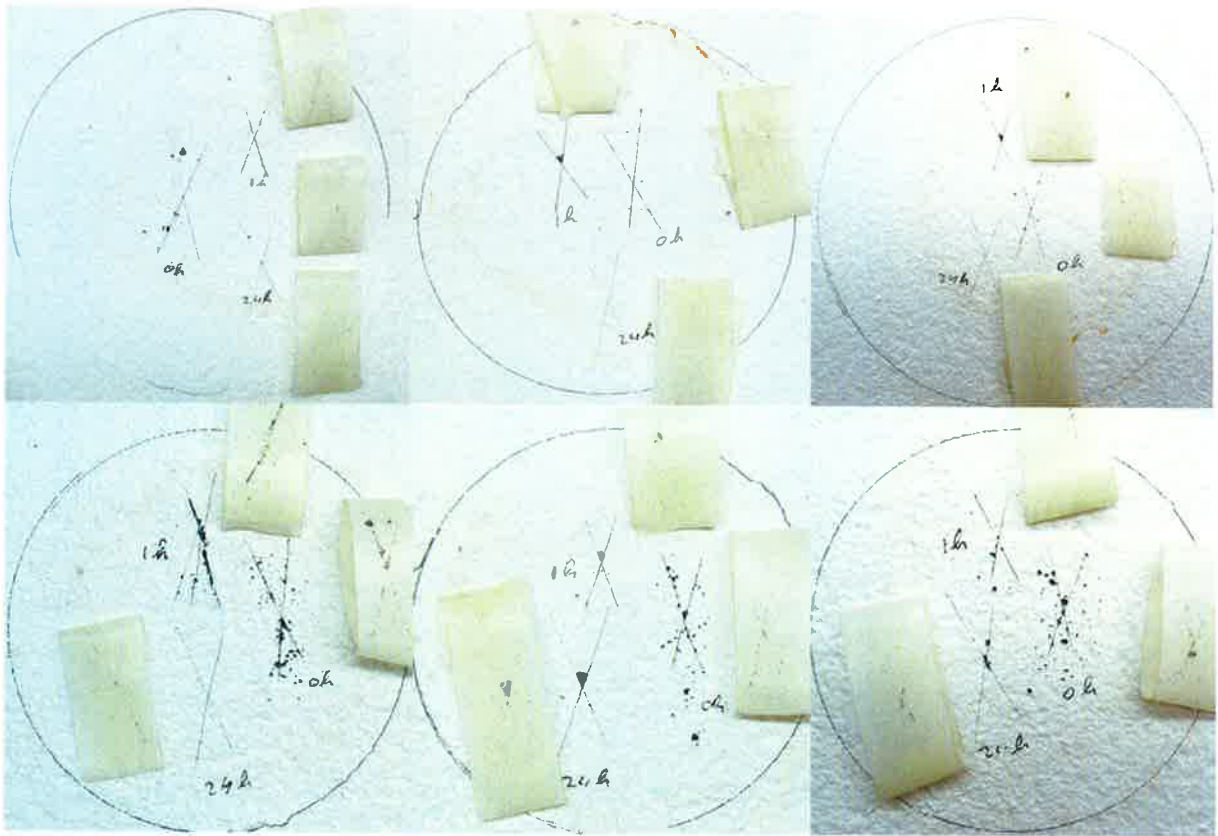
Photo 3: Adhesion after water exposure

The coating system shows no visual defects. The adhesion rating directly after the exposure period was slightly lower, but still acceptable. 80 days continued exposure to water is quite extreme for a roof. There is a difference of the adhesion rating directly after exposure between the two exposed panels. This might be due to differences in dry film thickness, but this has not been investigated. After 24 hours conditioning the adhesion recovered almost completely.

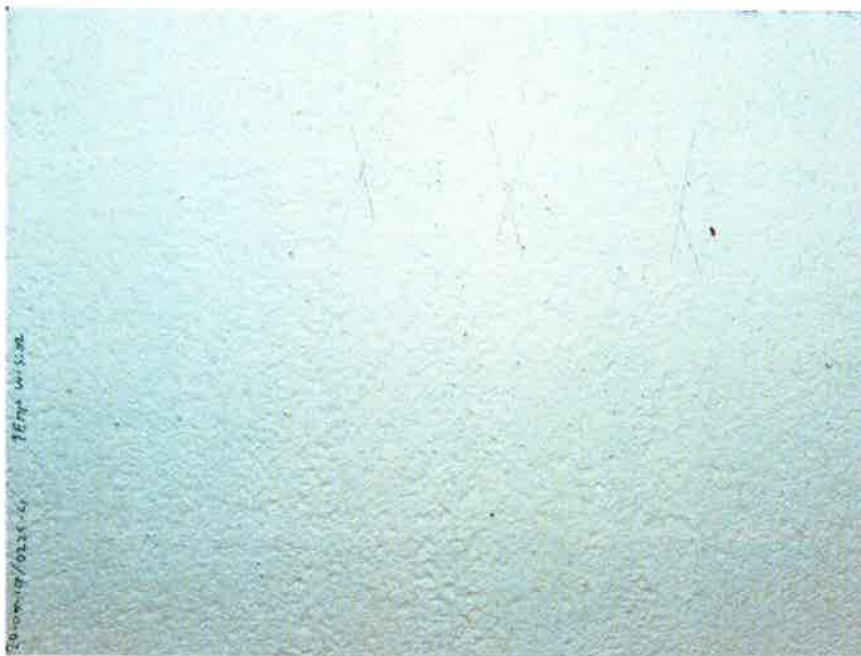
Photo 4: Adhesion after cyclic temperature test Panel 4

No visual defects have been observed after 80 days cyclic exposure.
The adhesion after 80 days cyclic temperature exposure has been rated as Class 5A.

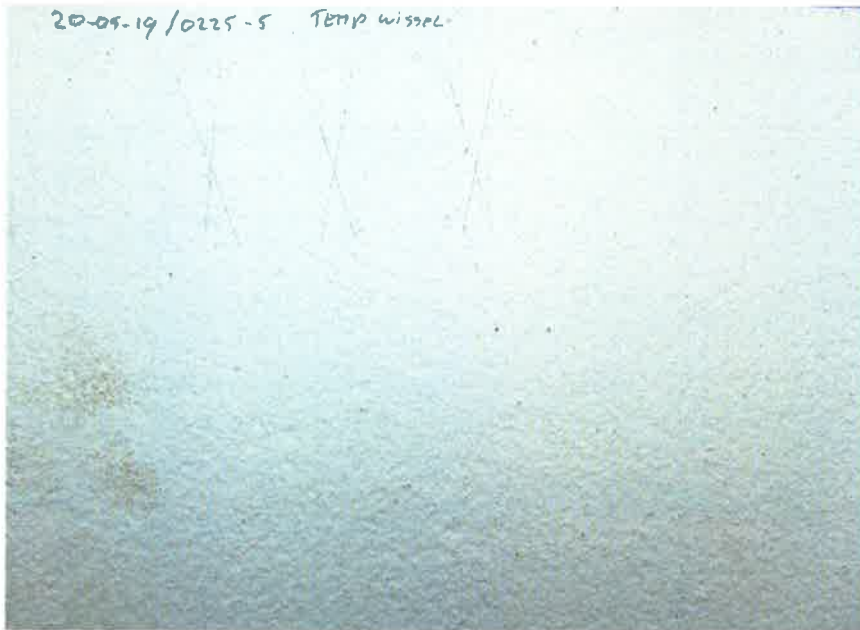
Photo 5: Adhesion after cyclic temperature test Panel 5

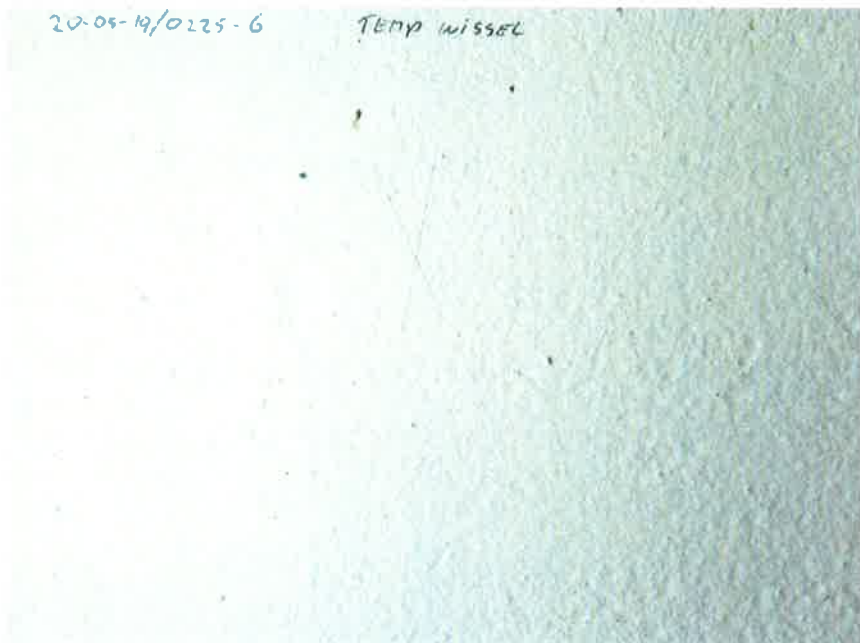
Photo 6: Adhesion after cyclic temperature test Panel 6
